## 1,000,000 Gallon Maryland Avenue Elevated Water Storage Tank Condition Assessment Report

Atlantic City MUA, NJ

**Date:**  
October 18, 2010

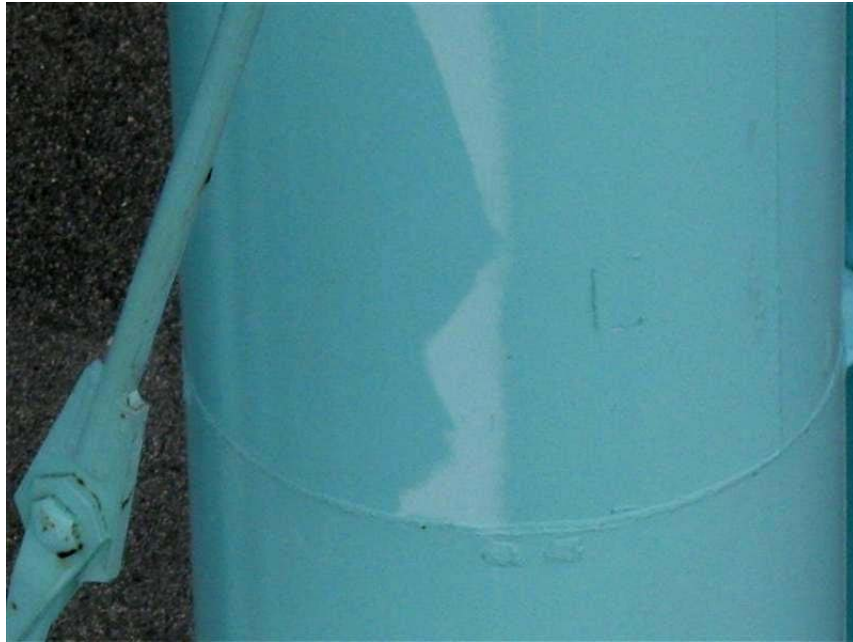
The exterior coating system is in fair condition. The appearance of the coating system is good to fair. The exterior coating system exhibits chalking, minor mildew growth, areas of minor to moderate corrosion, and minor delamination. There is no evidence of lead or chromium in the existing coatings. The existing coatings are 10.4 to 22.0 mils, dry film thickness. The adhesion of the existing coatings is good. Due to the thickness of the coatings and the amount of corrosion present on the structural components, as well as the fact that a clear coat finish was applied during the most recent renovation, it is not recommended to overcoat the tank exterior. (See photos # 1 -4).

**Photo #1** Coatings on exterior legs are in good condition. Clear coat finish is beginning to delaminate.

- **The tank exterior is in fair condition. There are several areas of moderate to severe corrosion on the underside of the bowl and weld seams and the clear coat finish on portions of the tank is failing. Based on the age of the coating system and the conditions observed it is recommended that the tank exterior be scheduled for an for a complete renovation to include complete removal of the existing coating by abrasive blast cleaning to an SSPC-SP6 Commercial standard and application of a new 3 coat system of primer, epoxy and urethane within the next 2 years.**

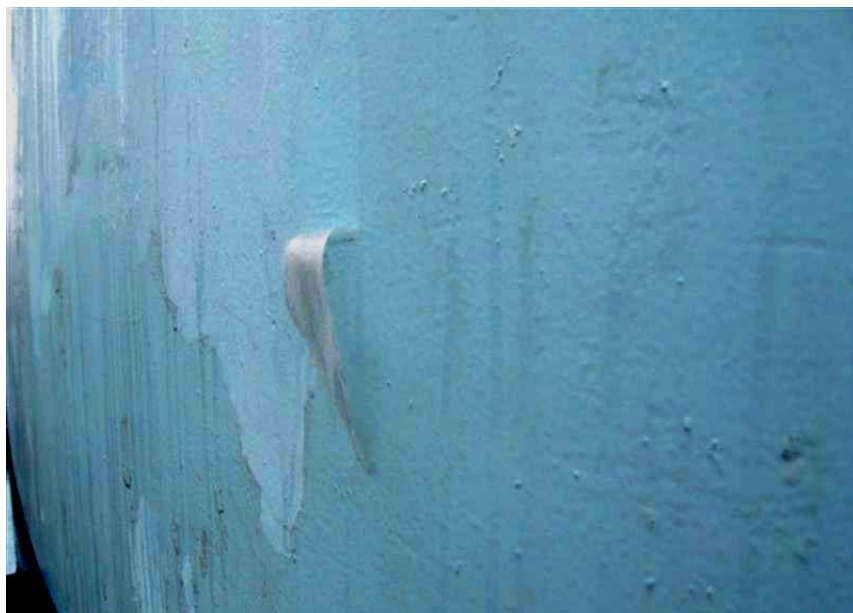
**Photo #2** Coatings on tank riser pipe are in good to fair condition. Chalking and minor mildew growth is evident, along with delaminating clear coat.

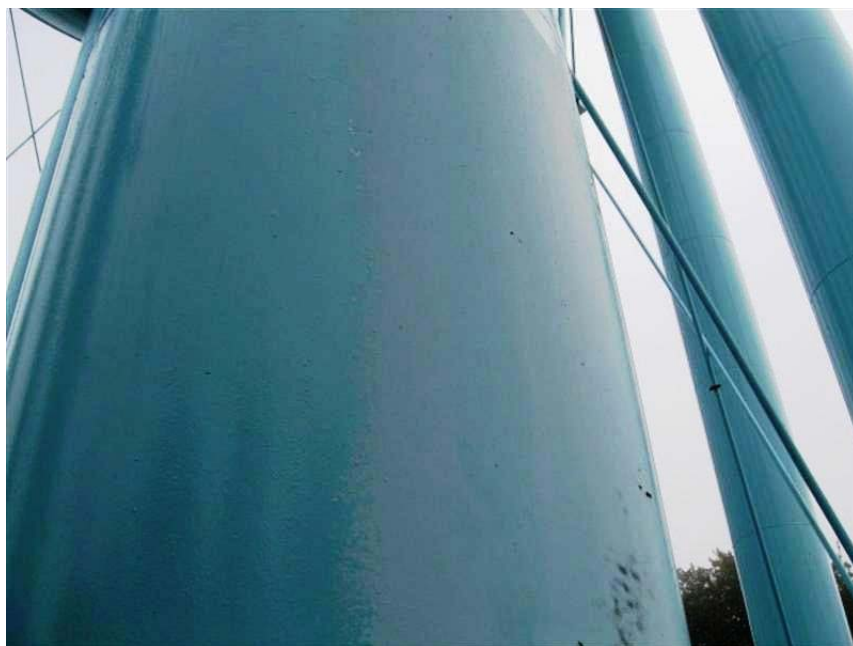
**Photo #3** Coatings on exterior riser pipe and legs are in good to fair condition. Note that left side of the photo shows the clear coat finish and right side was skipped during the clear coat application.

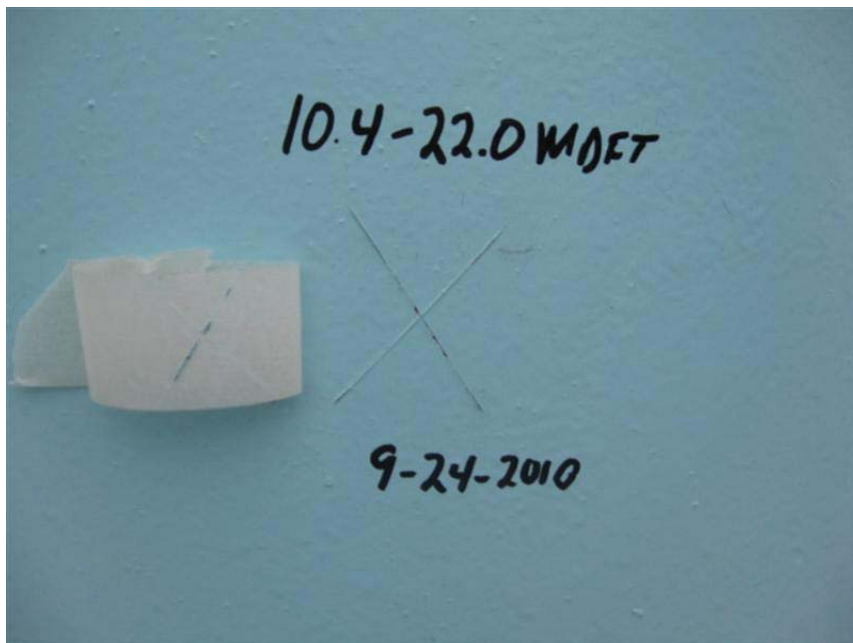
**Photo #4** Adhesion is good with a dry film thickness of 10.4 to 22.0 mils. Due to presence of a clear coat finish on the exterior, the tank cannot be overcoated and the next renovation must include removal of the existing coating system.

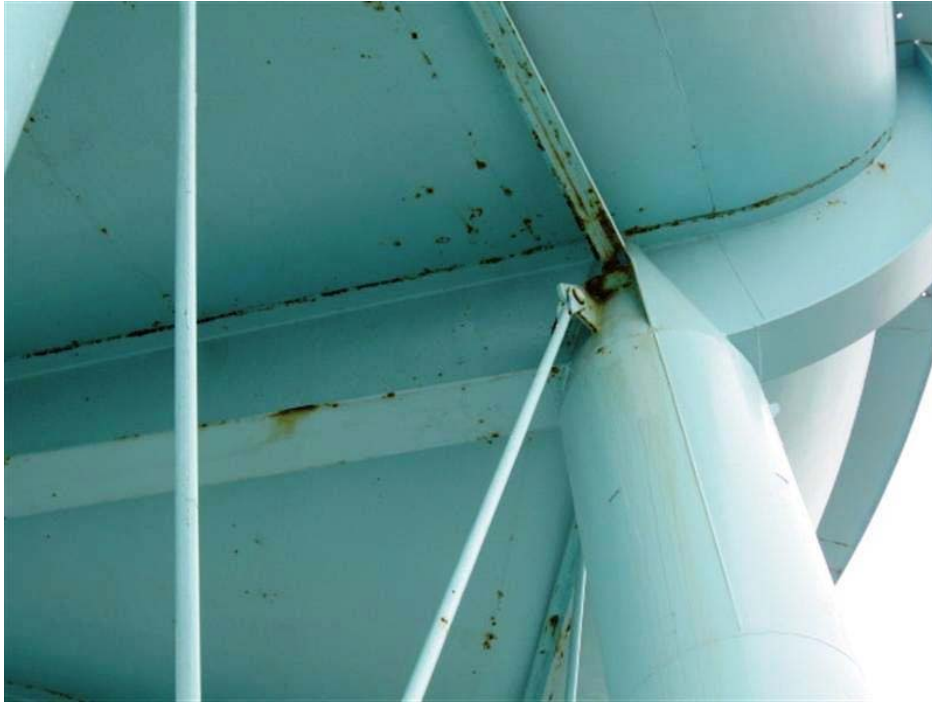
The coating system on the tank bowl is in fair condition. The exterior coating system on the tank bowl exhibits chalking, moderate corrosion, and mildew stains. There is some moderate corrosion on the structural beams and upper riser where it meets the bowl. (See photos #5 - 8).

**Photo #5** Corrosion and mildew growth on underside of tank bowl and on the structural beams.

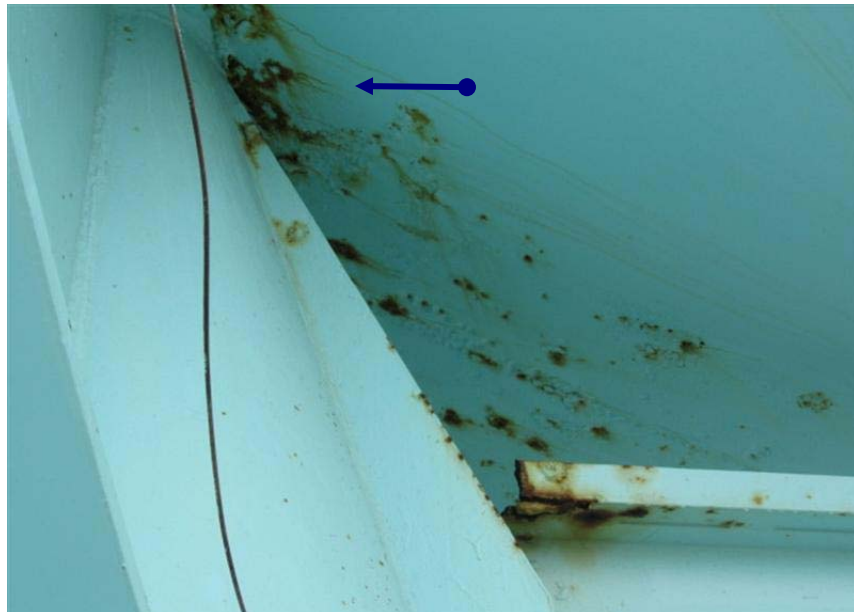
**Photo #6** Corrosion and mildew growth on the underside of tank.

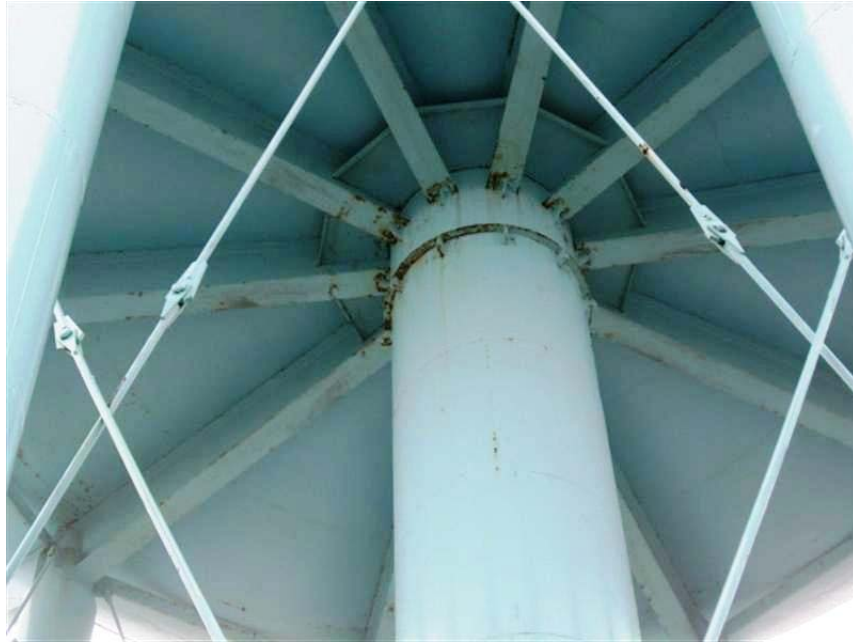
**Photo #7** Chalking of coating, and minor to moderate levels of corrosion on underside of tank bowl.

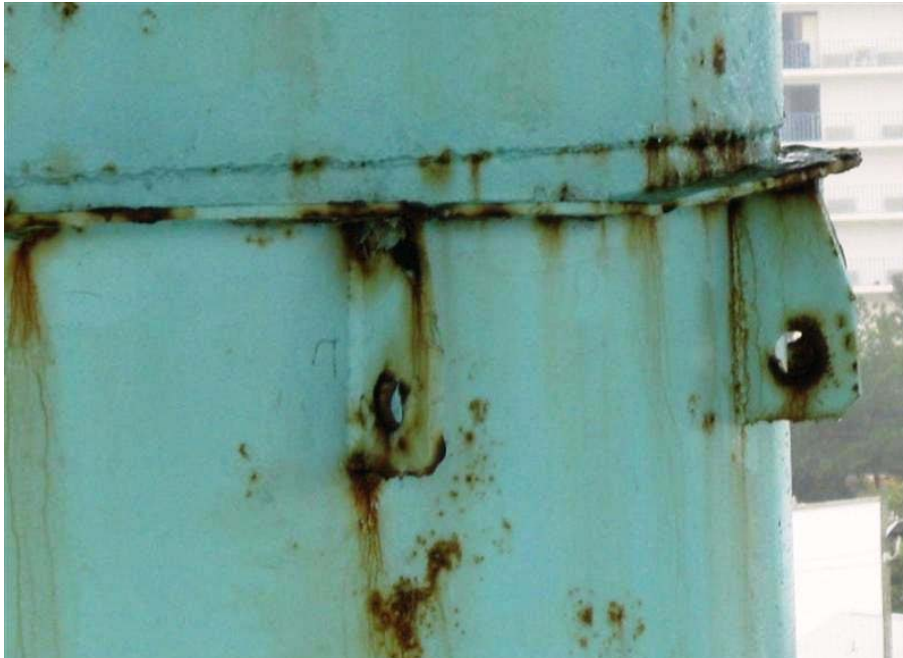
**Photo #8** Corrosion on the upper riser pipe.

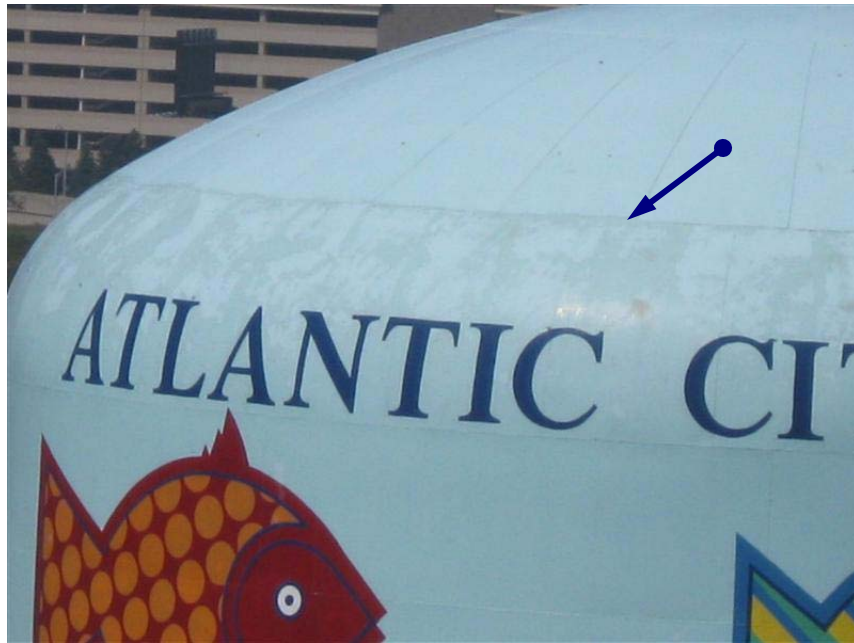
The exterior coating system on the tank sidewalls and roof is in fair condition. The appearance of the coating system on the tank sidewalls is good to fair. The clear coat finish is delaminating in several areas, but the overall appearance of the coating and "fish" logo is still good. The roof coatings are exhibiting areas of thinning, delamination of the clear coat, and some minor corrosion. (See photos # 9 - 12).

**Photo #9** Coatings on sidewall are in good condition. Note delamination of clear coat finish along knuckle. (arrow)

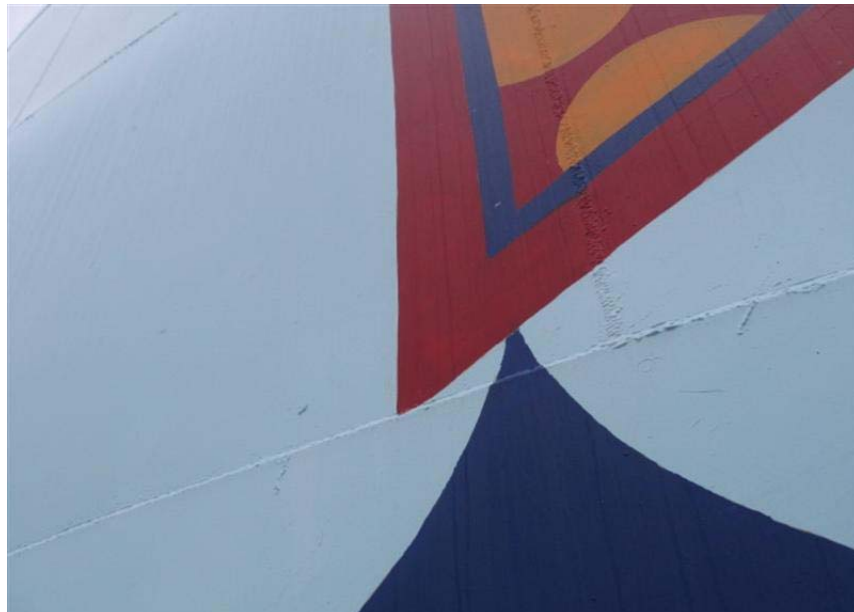
**Photo #10** Coatings on sidewall are in good condition

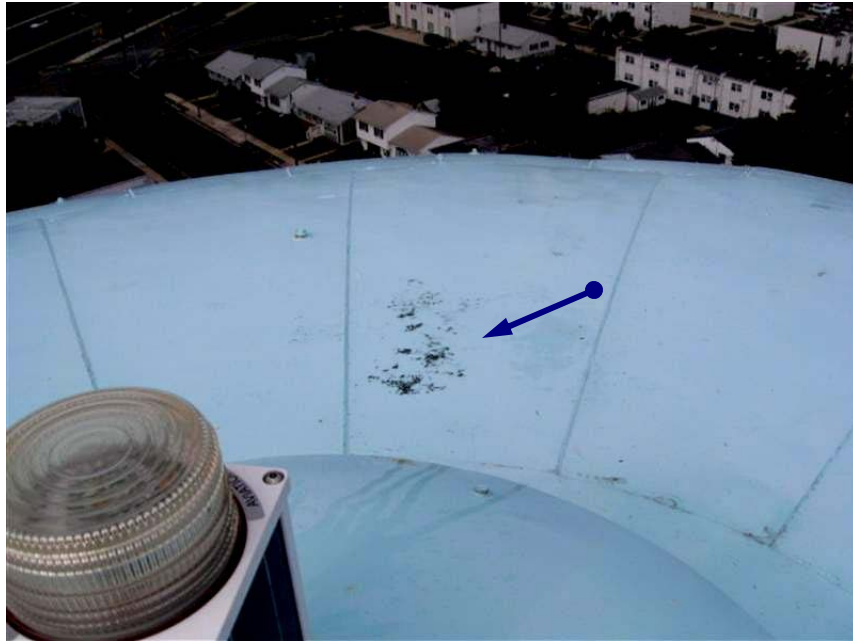
**Photo #11** Mildew and staining on roof. Coatings are in generally good condition.

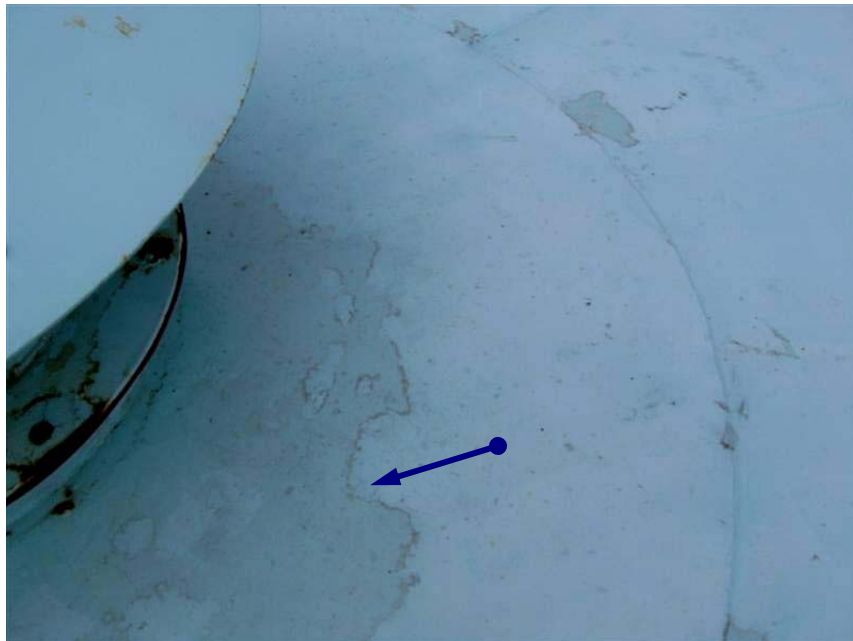
**Photo #12** Coatings on roof are thinning and clear coat finish is wearing and delaminating.

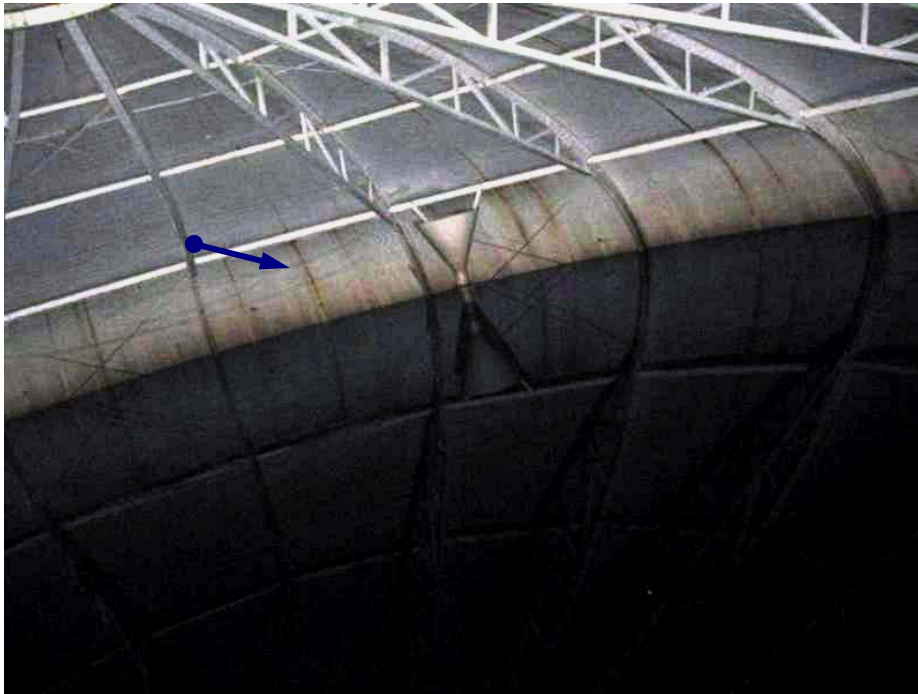
The interior epoxy coating system on the roof plates and the area above the high water level is in fair to poor condition. The interior epoxy coating system exhibits areas of corrosion, delamination, and organic staining. (See photos # 13 - 16).

The interior epoxy coating system on the tank sidewalls is in good to fair condition. The interior epoxy coating system exhibits organic staining, likely from iron and/or manganese, and some minor active corrosion. (See photo # 13).

**Photo #13** Coatings on the interior are in good condition with some minor corrosion and organic staining on the sidewalls and roof.

- **The interior epoxy coating system appears to be in good to fair condition based on the limited view of the walls and roof. There is a light build up of organic staining on the walls and minor corrosion on the roof structure, sidewall panels, and edges.**
- **It is recommended that a full washout inspection and disinfection be performed on the tank interior to further determine the condition of the coatings. Without better visual evidence of the condition of the interior coatings a definitive recommendation cannot be made.**

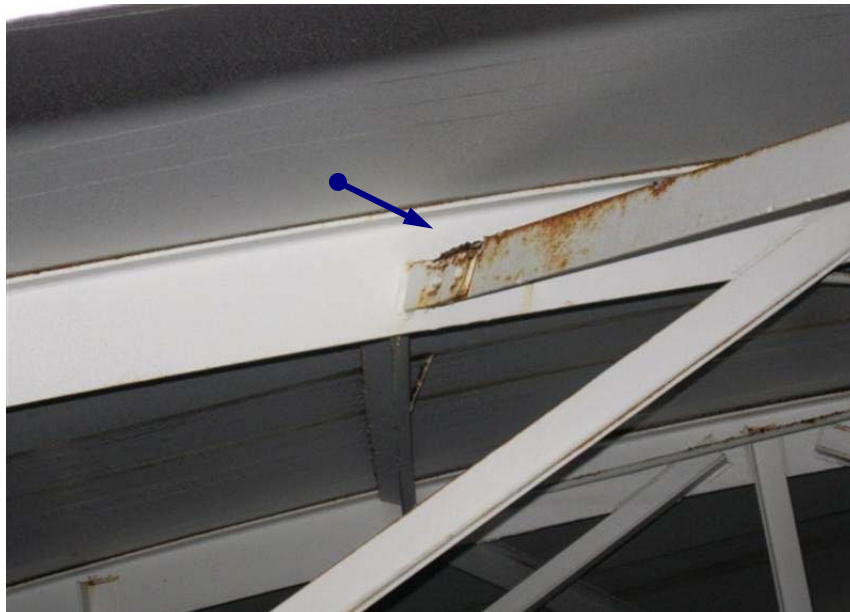
**Photo #14** Coatings on interior roof and above the high water level are in fair condition. There is active corrosion and delamination on areas on structural beam edges.

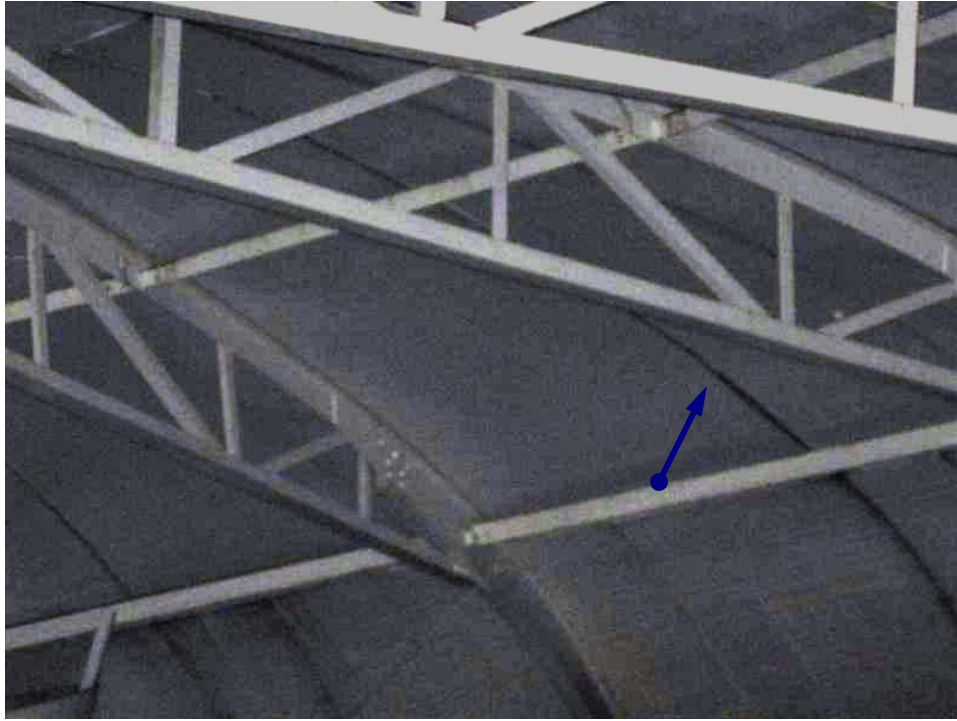
**Photo #15** Minor corrosion on tank roof panels and weld seams.

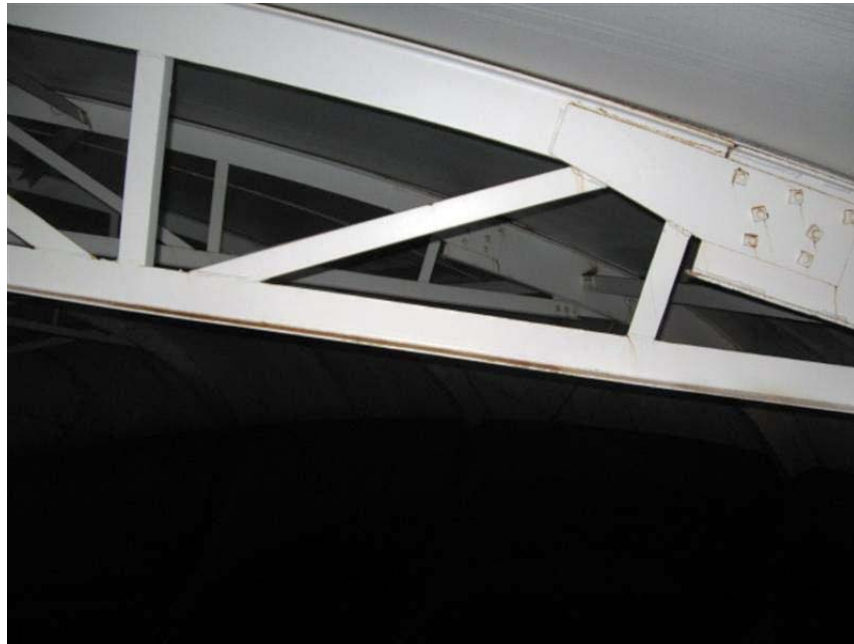
**Photo #16** Coatings on roof structure and panels are in generally good condition.

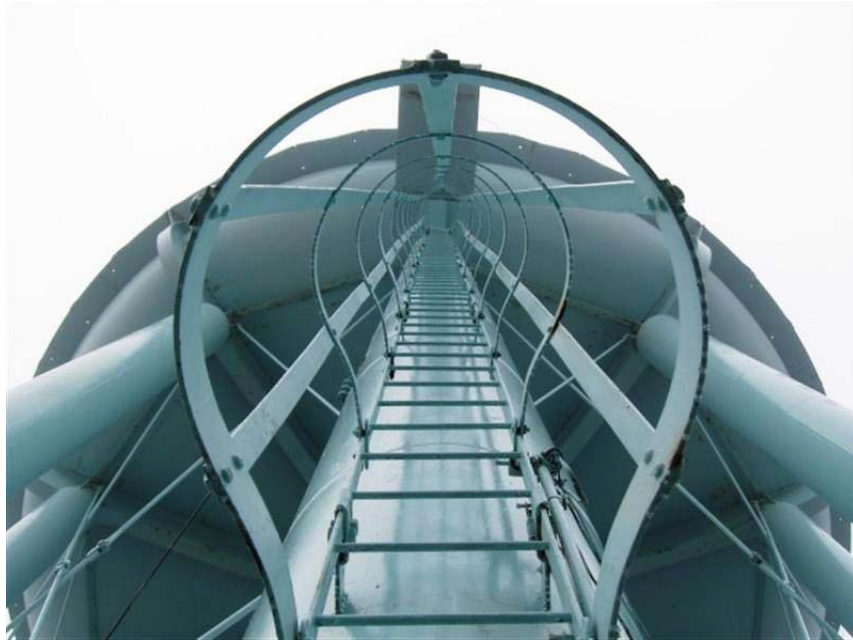
The access ladder attached to the exterior leg is in good condition. It is not equipped with a safety climb system.

There is not a suitable ladder gate attached to the ladder. (See photos #17)

**Photo #17** Main access ladder is in good condition, but does not contain a suitable safety climb device or a tamperproof ladder gate.

- **It is recommended to install additional signs on the fencing surrounding the tank.**
- **It is recommended to install a lock on the roof hatch cover.**
- **It is recommended to install a ladder gate on the lower access ladder.**

- **Install a new aluminum or stainless steel ladder gate.**
- **Install new aluminum frost proof, vacuum pallet roof vent.**
- **Install new cable safety climb systems on all ladders.**

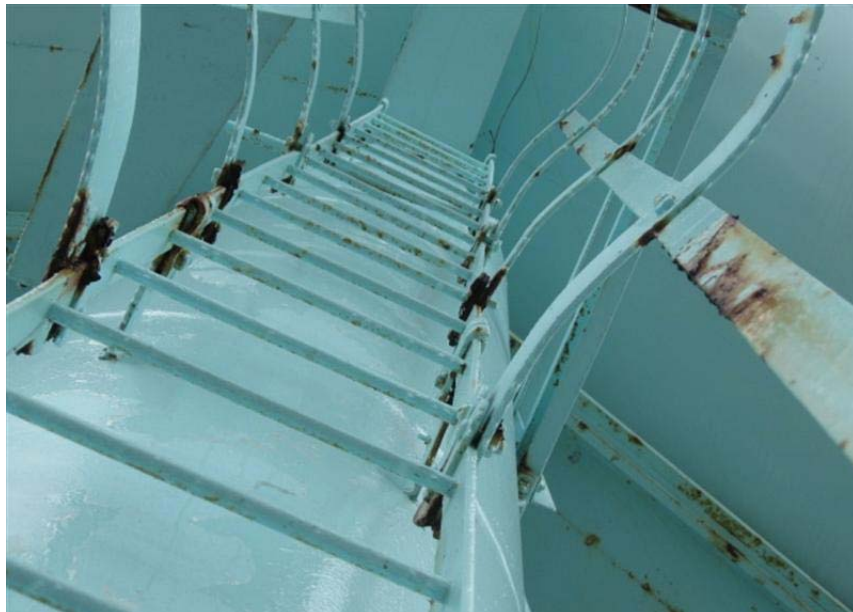
**Photo #18** Moderate levels of corrosion on the main access ladder cage.

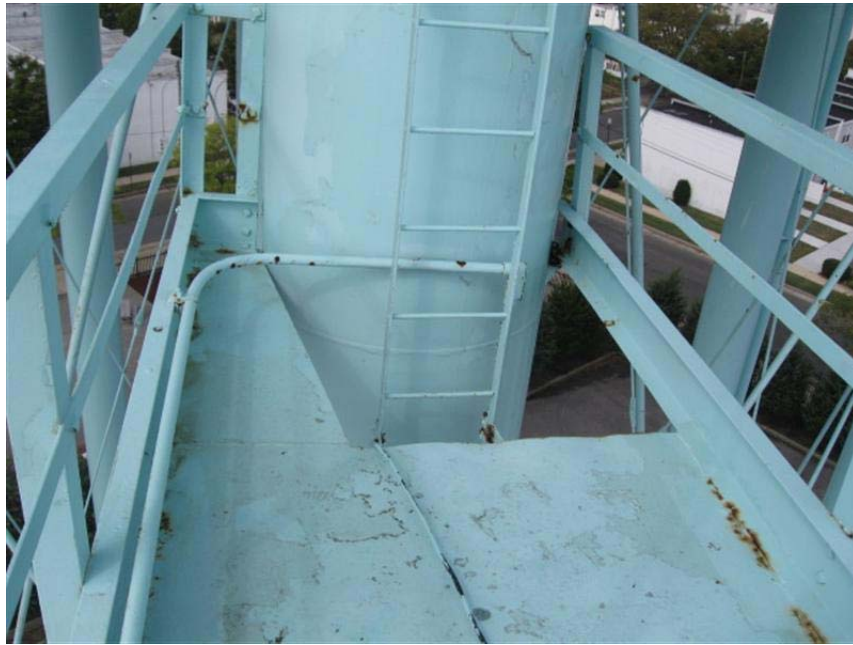
**Photo #19** Areas of moderate corrosion on ladder balcony. Clear coat finish his delaminating on balcony floor.

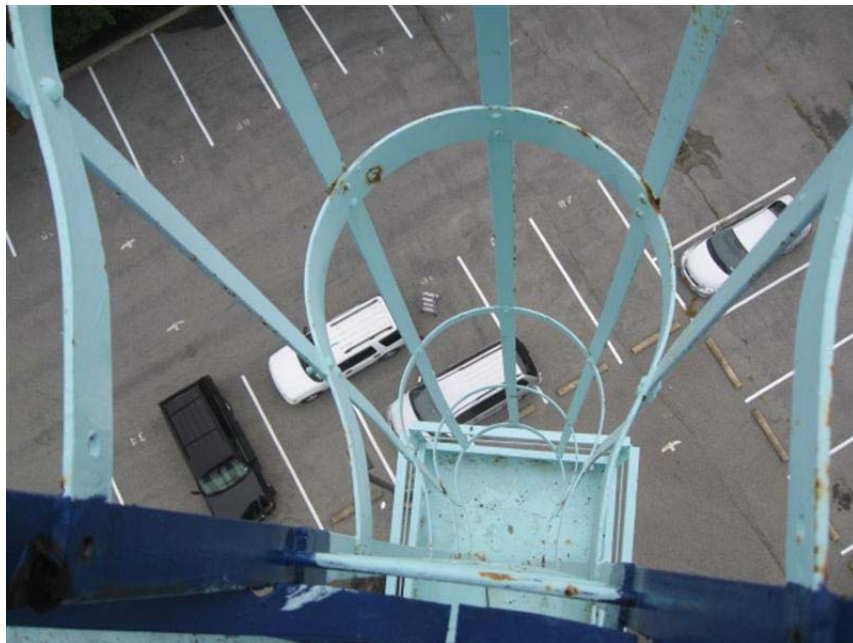
**Photo #20** Second tier access ladder does not contain a suitable safety climb device.

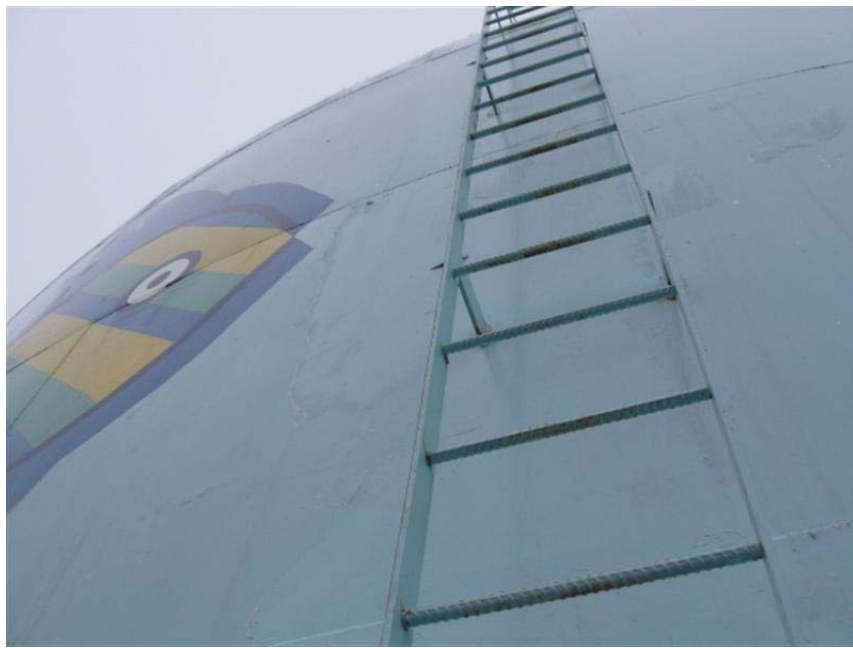
**Photo #21** Upper sidewall ladder is in good condition but does not contain a suitable safety climb device.

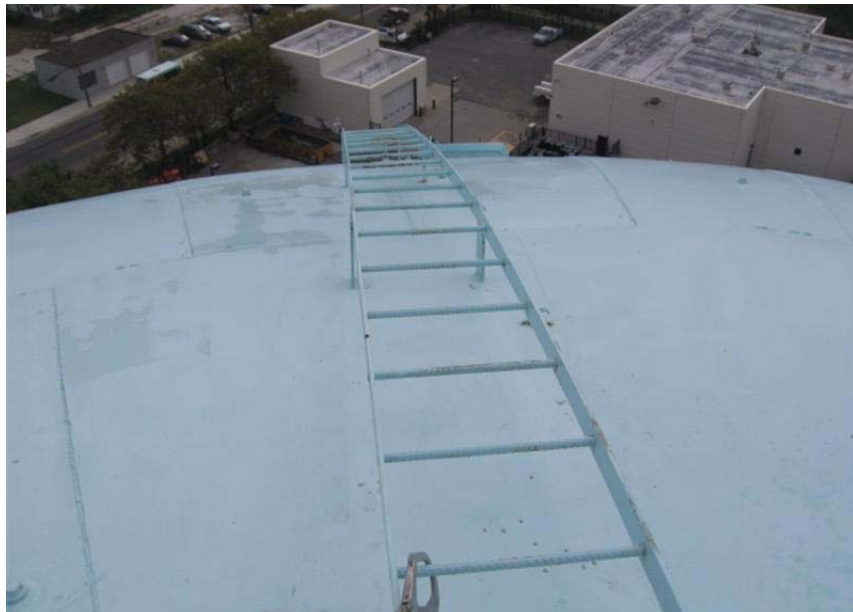
The roof access ladder is in good condition and does not contain a safety climb system. (See photos # 17 - 23)

**Photo #22** Dome roof ladder is secure and in good condition, but does not contain a safety climb device.

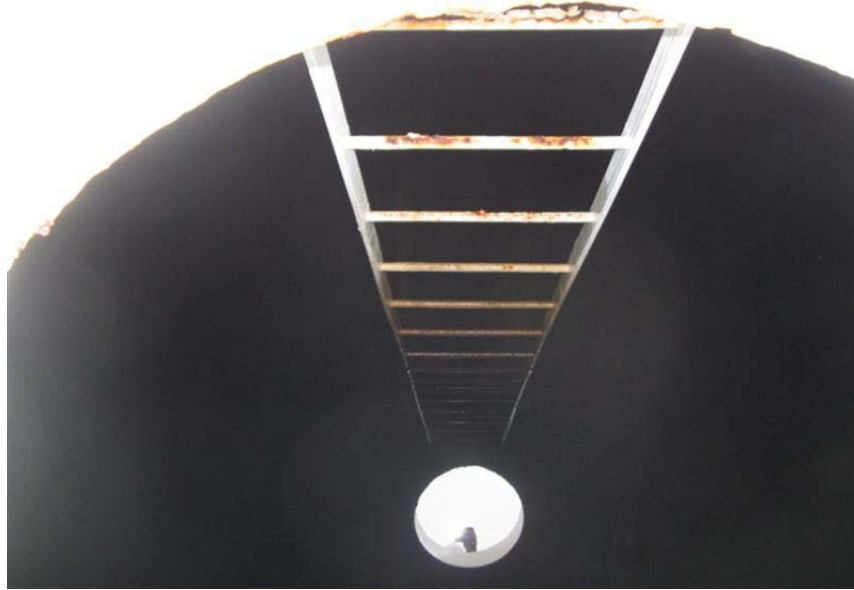
The interior ladder is in fair condition and is exhibiting corrosion on the upper rungs that were visible during the inspection. It does not contain a safety climb system.

**Photo #23** Interior ladder exhibits moderate levels of corrosion. There is no suitable safety climb device attached to this letter.

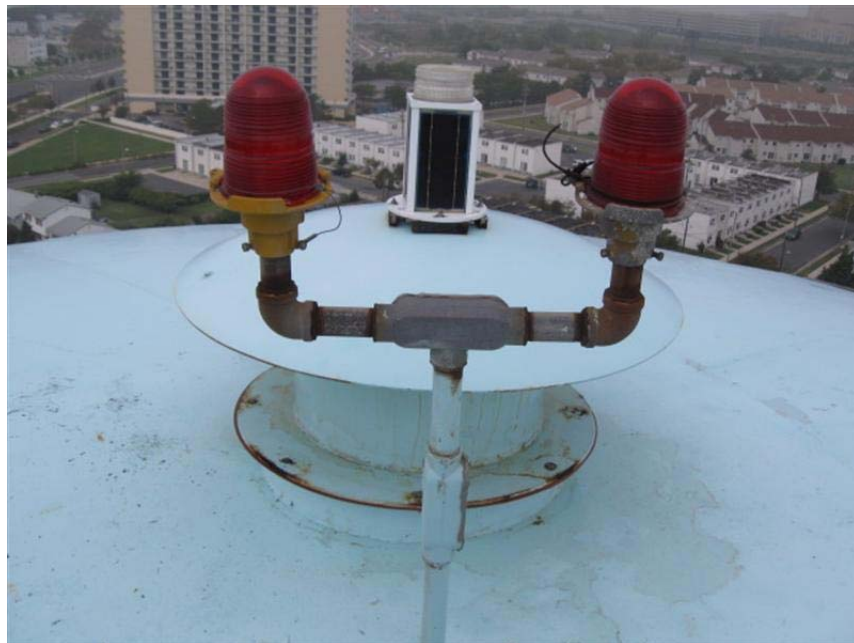
There is an aviation warning light on this tower. (See photos # 24).

**Photo #24** Aviation warning like on the roof is not functioning. New battery-operated aviation flight has been attached to the roof vent. Photo also shows center roof vent.

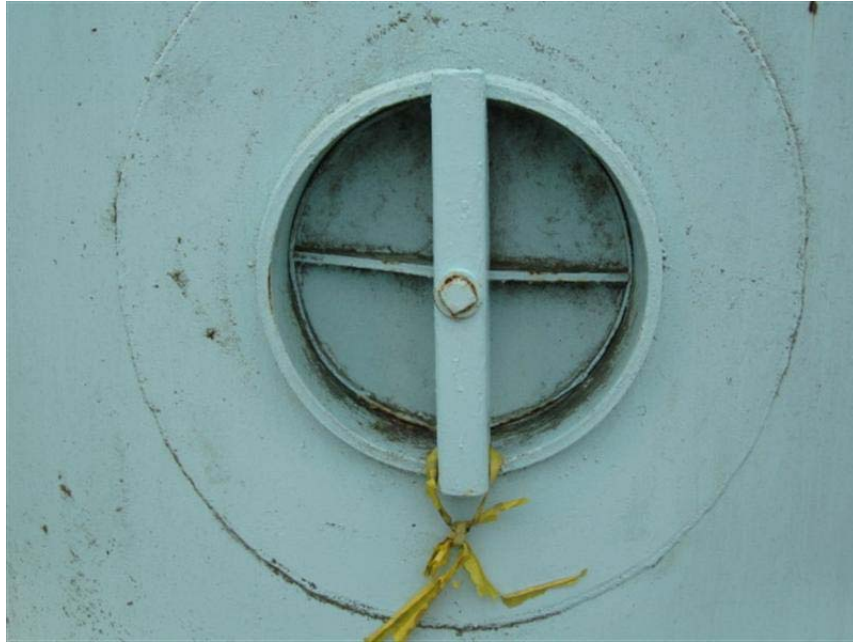
The primary riser access is a 24 inch diameter clamp style hatch that does not meet current AWWA guidelines. (See photo # 25).

**Photo #25** 24 inch riser manway is in good condition. Recommend installation of a new 30 inch bolted cover man way with davit arm on opposite side of riser pipe.

- **It is recommended to add a secondary 30" bolted flange access cover with Davit arm on the opposite side of riser.**

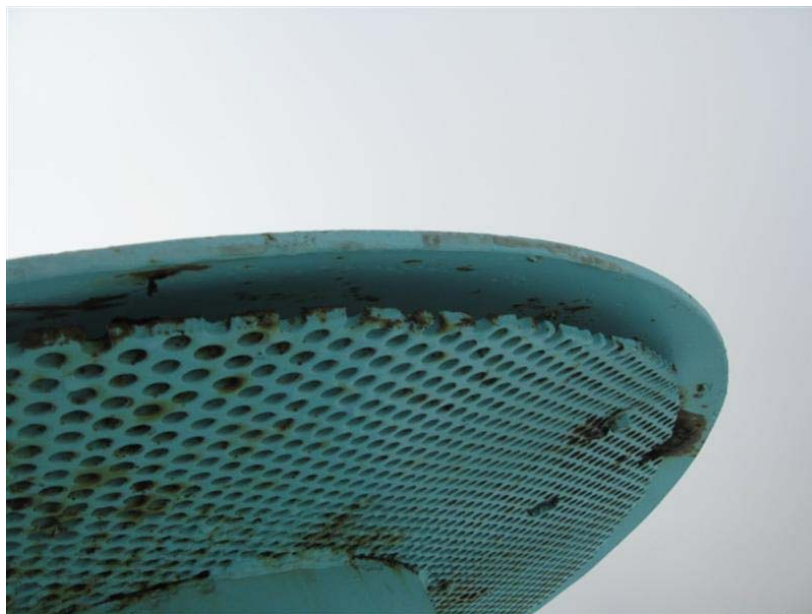
AWWA guidelines require that a tank have a vent, which is both freeze-proof and insect-proof, on the top of the tank to prevent contamination from birds, bats and insects. These guidelines also suggest the screen be protected from direct contact with the elements. The existing roof vent does not comply with current AWWA and NJ DEP guidelines. (See photos # 24 & 26).

**Photo #26** Roof vent does not meet current standards and should be replaced with a modern aluminum frost proof that system to prevent insects and birds from entering the water chamber.

- **It is recommended to replace the existing roof vent with a new aluminum frost proof, vacuum pallet vent system.**

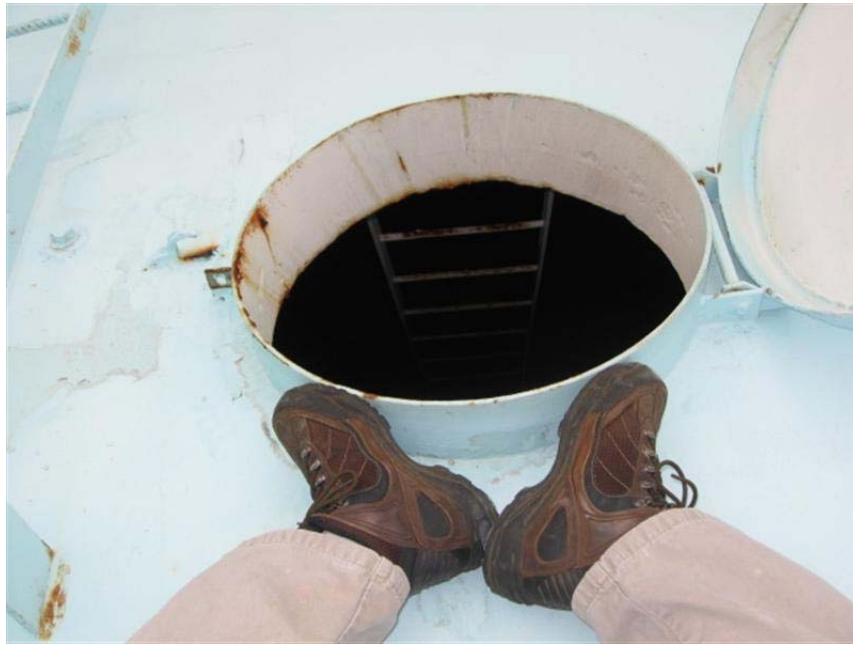
The 24" round roof hatch meets current OSHA, AWWA standards and NJ DEP guidelines which require that roof hatch be a minimum of 24 inch diameter and be framed 4" to 6" above the surface of the roof at the opening and that it should be fitted with a solid watertight cover which overlaps the framed opening and extends down around the frame a minimum of two inches to prevent contaminated rainwater from entering the tank.

**Photo #27** 24" round roof access hatch. Roof hatch cover overlaps curb to prevent contaminated rainwater from entering the water chamber.

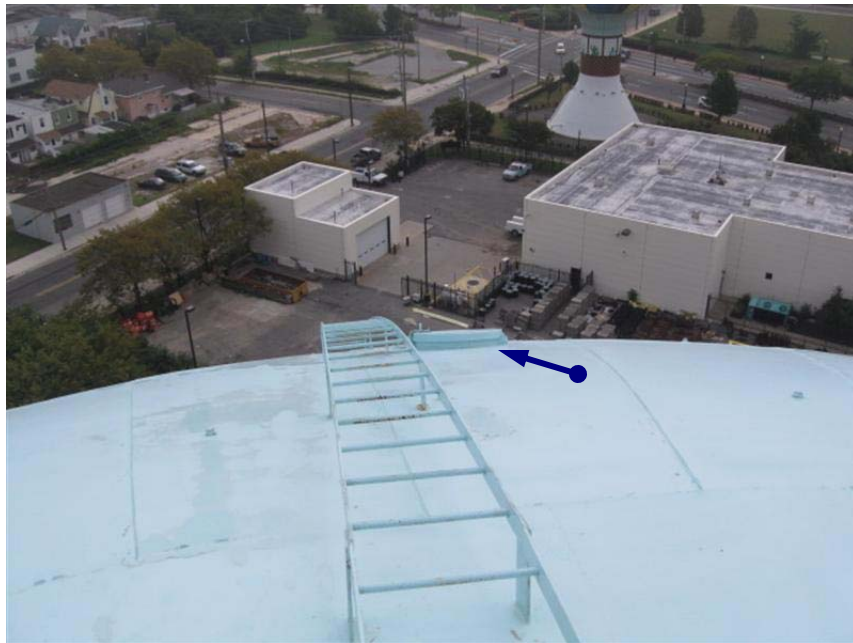
The roof hatch was closed but unlocked when the tank was inspected. (See photos # 27 & 28).

**Photo #28** Roof access hatch meets current standards and was not locked at the time of the inspection.

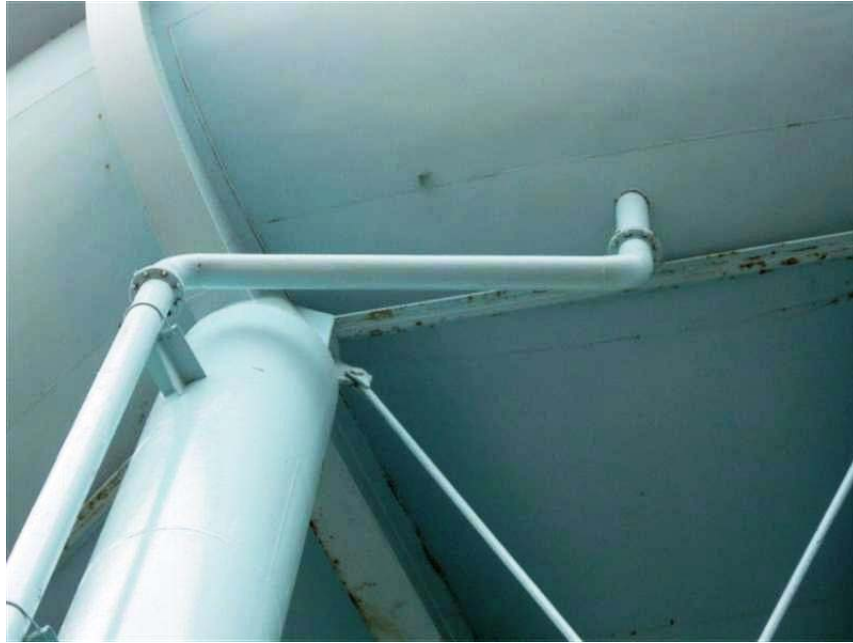
**Photo #29** Overflow pipe is secured to the leg and is in good condition

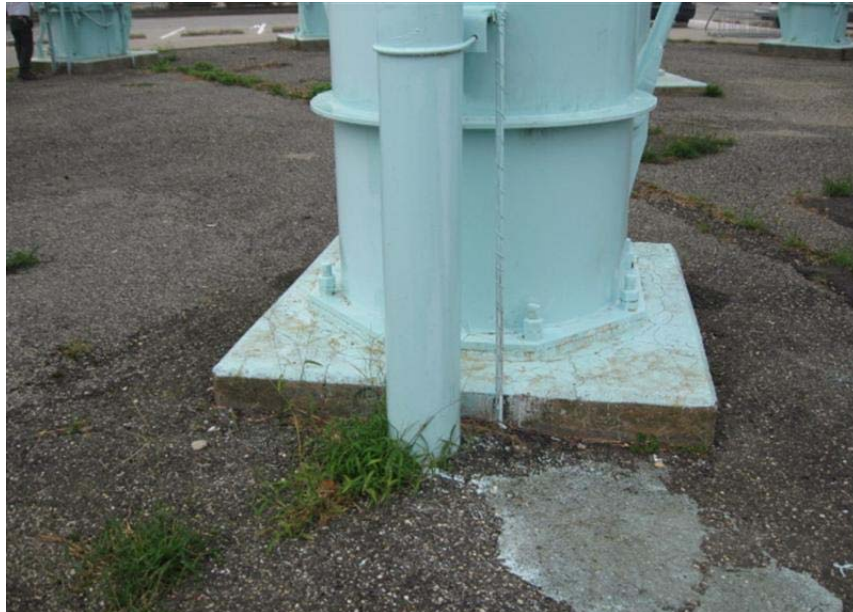
AWWA guidelines require the overflows on elevated tanks and standpipes discharge at an elevation no higher than 12 to 24 inches above ground and discharge over a drainage inlet structure or splash plate. The overflow pipe on this tank enters the ground at the tank base and empties at an unknown location, likely in a catch basin in an adjacent street. The overflow outlet should be located and inspected to ensure the proper screen cover is installed over the outlet end to prevent insects, birds and vermin from entering the tank. (See photo # 29 - 30).

**Photo #30** Overflow terminates below grade and likely has an outlet in the adjacent street. Further investigation should be done to ensure a proper vent screen is in place to prevent vermin from entering the water chamber.

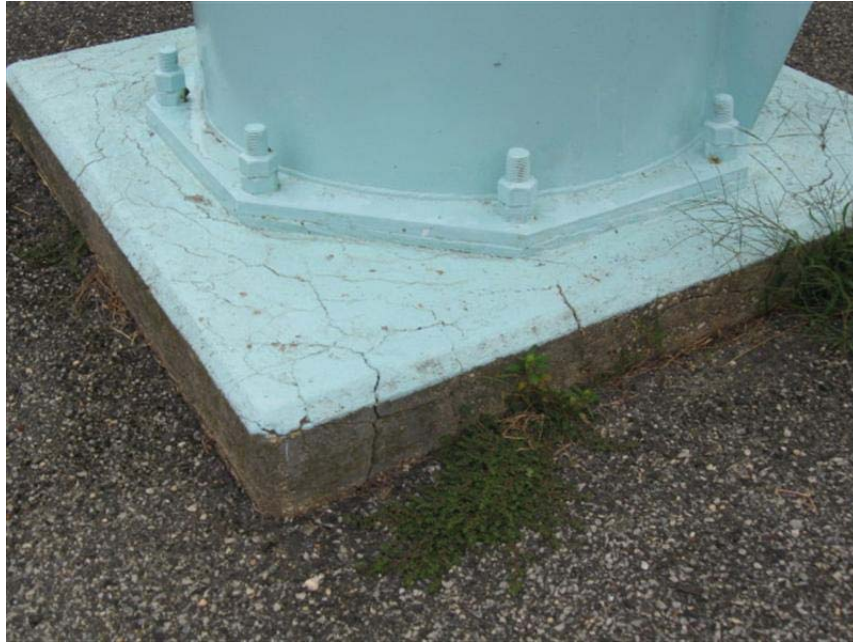
The concrete foundations were coated to prevent freeze-thaw damage. The coating has worn and is no longer protecting the concrete. The visible areas of the foundations are in fair condition, exhibiting some moderate to severe cracking and flaking of the concrete.

Although many of the cracks appear to be superficial, the width of a few of the cracks makes it likely that they are deeper than an inch or two. It is difficult for a crack in concrete to open wide without some depth. The depth of a crack should only be of a structural concern if it penetrates the area of the foundation that is carrying and transferring the loads, which cannot be known from visual observations of the surface.

From visual observation, the cracks do not penetrate the load bearing area of the foundation and can simply be properly cleaned and sealed. The only way to be certain of any damage to the load bearing pier is to take the worst looking pier and break away all the cracked concrete to see how far the cracks go. After the investigation is complete, form and pour a new concrete “cap” over the exposed pier, keeping in mind there are certain procedures and material considerations for bonding new concrete to old.

**Photo #31** Foundation piers are in good to fair condition. There are moderate levels of cracking and spalling on several of the foundation piers.

- **It is recommended to remove all loose and cracking concrete on the foundations, properly prepare and repair each area, then seal and coat with epoxy to protect from further deterioration.**

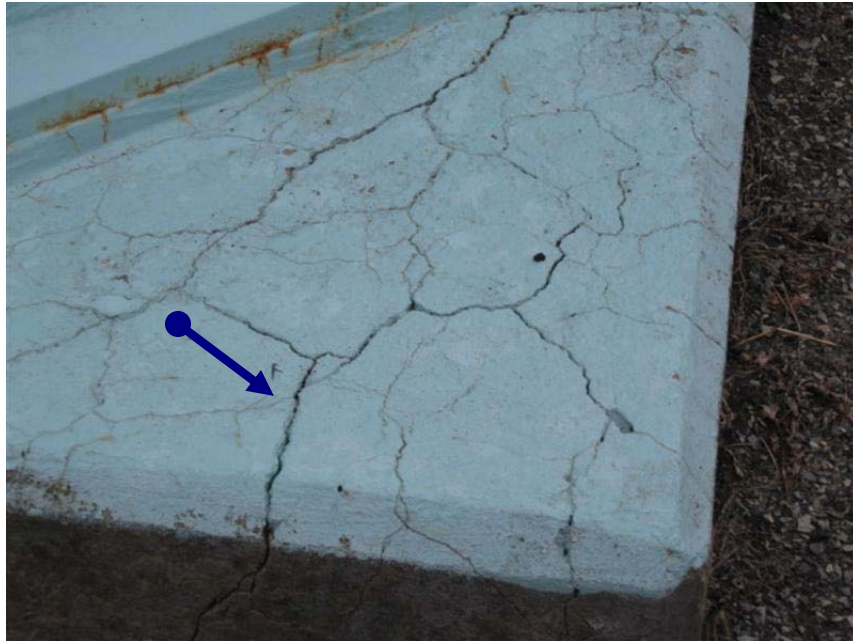
**Photo #32** Cracks should be filled and sealed to prevent the intrusion of water and possible freeze-thaw damage to the foundation.

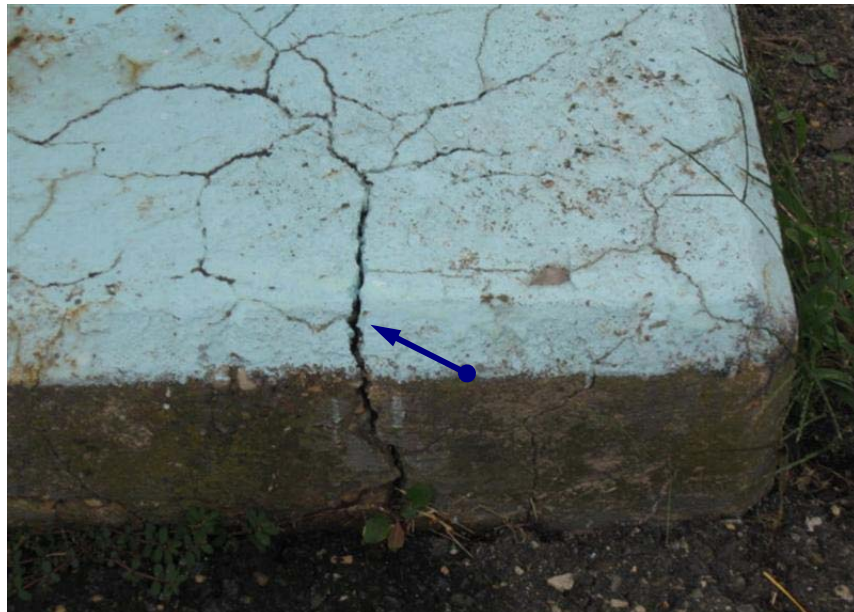
**Photo #34** Cracking and spalling of concrete foundation piers

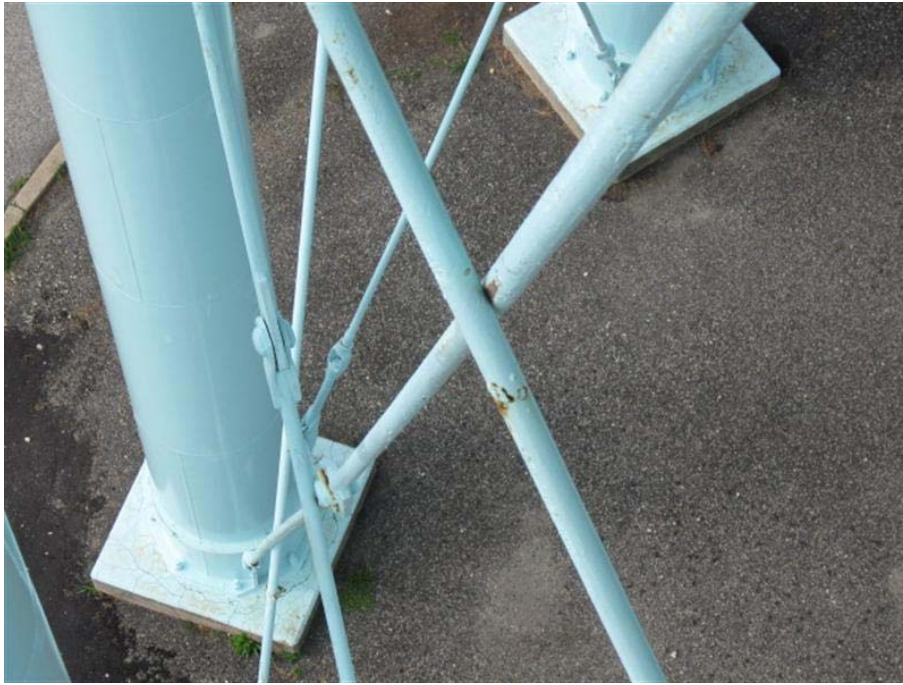
The wind rods and sway rods appear to be in good condition. (See photo #35 - 37)

**Photo #35** Wind rods are tight and in good condition.

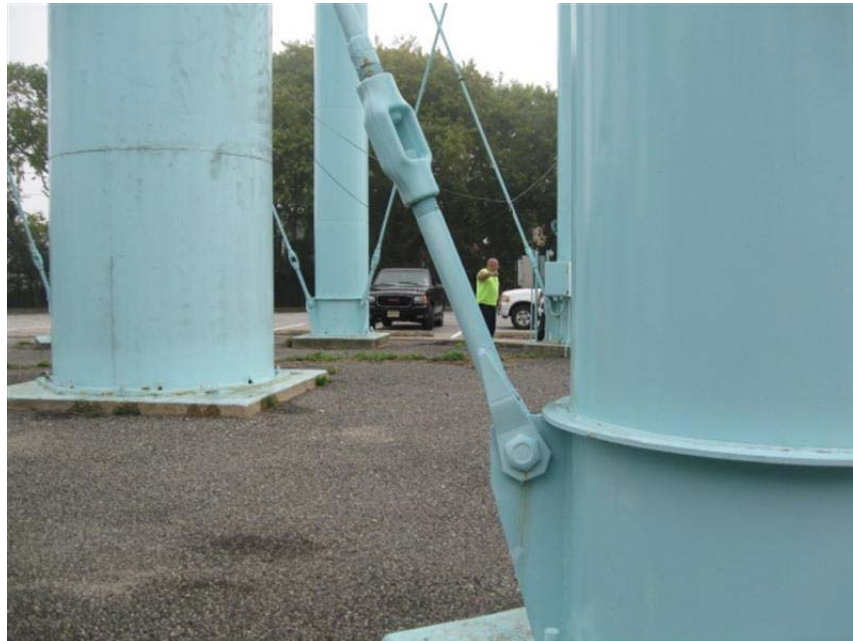
**Photo #36** Wind rod yokes and turnbuckles are in tight and in good condition.
