## 1,000,000 Gallon Maryland Avenue Elevated Water Storage Tank Condition Assessment Report

Atlantic City MUA, NJ

**Date:**  
October 18, 2010

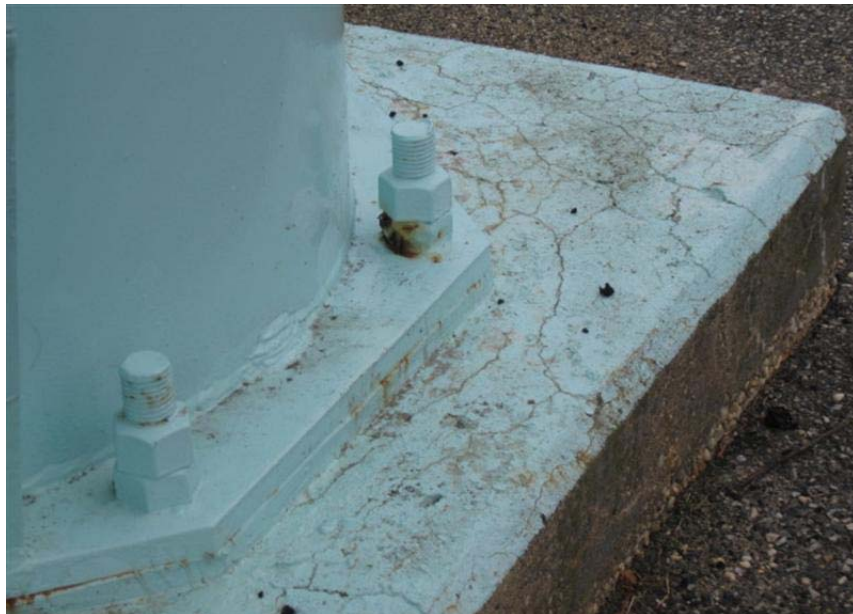
The anchor bolts are generally tight and in good condition. There is corrosion and significant loss on some of the nuts, and minor corrosion on several anchor bolts, but not enough to be of concern. During the next renovation, new nuts should be installed. (See photos #38 - 40)

**Photo #38** Anchor bolts and nuts are in generally good condition with only moderate levels of corrosion on several of the nuts.

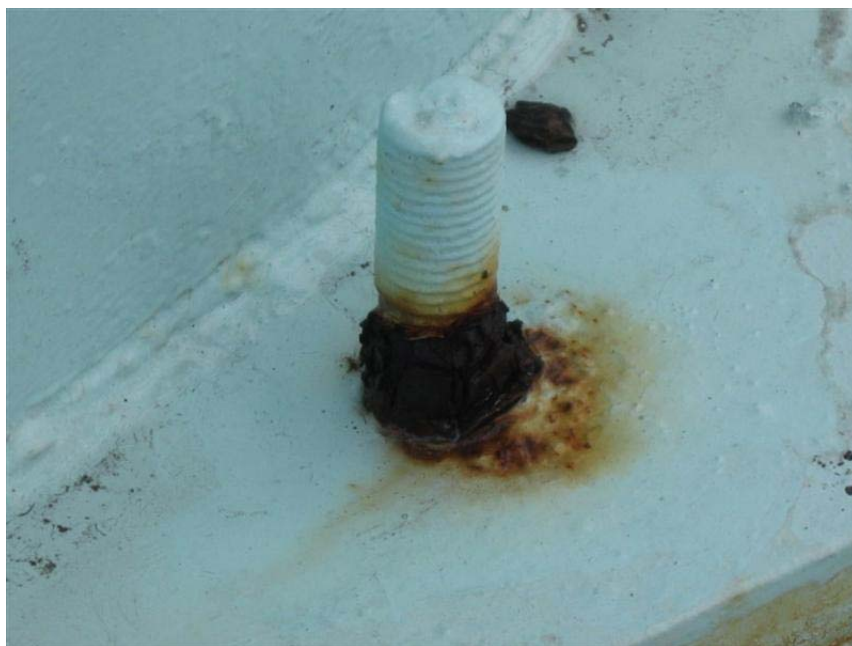
**Photo #39** Approximately 6 anchor bolts and nuts exhibit severe levels of corrosion and should be replaced during the next renovation.

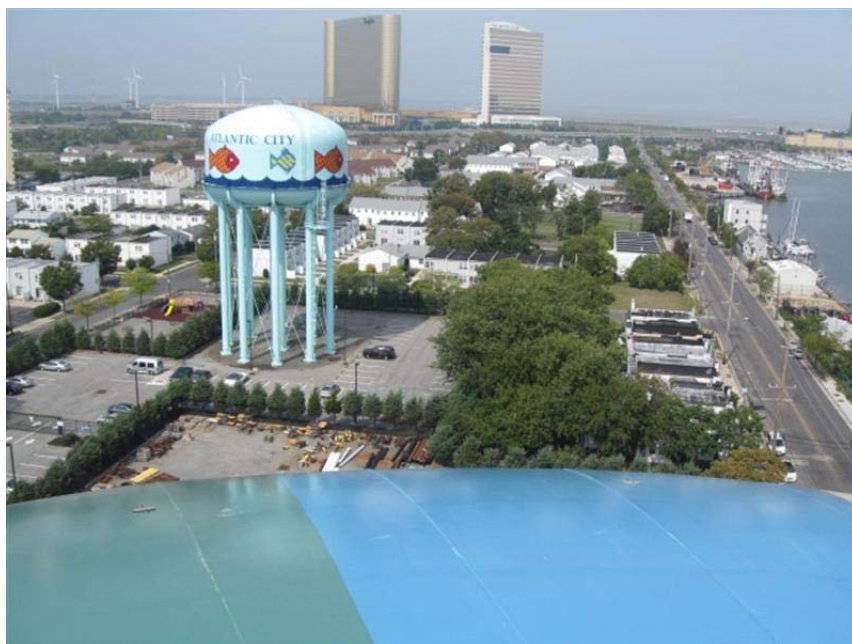
The site is secure and there is a fence that surrounds the entire facility.

Current US Dept. of Homeland security guidelines and NJ DEP guidelines suggest that all water tank sites be fenced and locked. “Tampering with this facility is a Federal Offense” signs be posted on and around the site. (See photo #41)

**Photo #41** Site is fenced and secure.

- **It is recommended to install additional signs on the fencing surrounding the tank.**
- **It is recommended to install a lock on the roof hatch cover.**
- **It is recommended to install a ladder gate on the lower access ladder.**
